## COMPARISON OF PREDICTED AND EXPERIMENTAL THERMAL FATIGUE LIVES OF T -91 STEEL TUBE

G.R.Jinu<sup>1</sup>, \*P.Sathiya<sup>1</sup>, A.Rathinam<sup>2</sup> & G.Ravichandran<sup>2</sup>

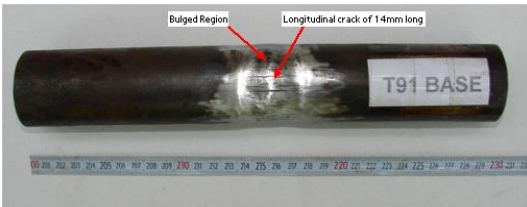
The macrograph of the failed base metal tube is shown in figure 9. From figure 9, it is observed that

lot of surface cracks are obtained in the tube subjected to thermal fatigue after 85 cycles.

**Fig.9 Visual inspection of failed base metal**

A 14mm long longitudinal crack is visually identified in the failed base tube at the heated zone. The tube becomes bulged in the heating zone, which is clearly seen. The failed tube is then subjected to liquid penetrant test in order identify the small surface cracks.

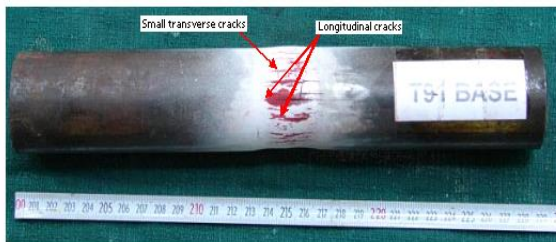
**Fig.10 Liquid penetrant examination of failed base specimen**

The macrograph of the failed base metal tube specimen is subjected to liquid penetrant test, to identify the small surface cracks is shown in Figure 10. It clearly shows that lot of longitudinal cracks is found in the heated zone and from the longitudinal crack small transverse cracks are also identified, which are invisible in the visual examination. The failed tube is then sectioned and subjected to metallographic study.

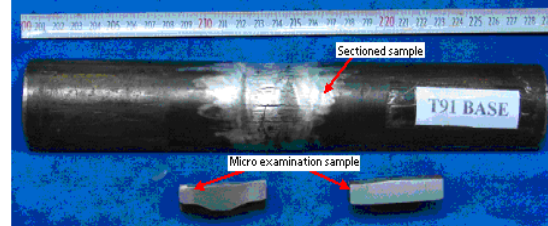
**Fig.11 Sectioned view of the failed base tube**

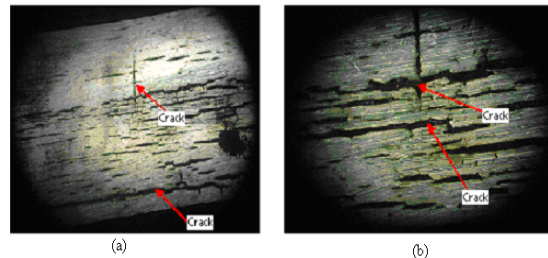
**Fig.12 Magnified view of the surface crack obtained in the failed base tube**

Before subjecting to the micro analysis the polished sample is subjected to macro study. The macro photographs are taken in the outer surface of the failed tube to get the closer view of the cracks obtained in the surface, while the micro structure is taken in the cross-section of the failed tube on the thickness side to study the depth of penetration of the crack. Figure 12 (a) shows the magnified view of the surface crack obtained in the failed base metal tube subjected to thermal fatigue and it is clearly identified that a lot of longitudinal cracks are developed in the heated zone and from the longitudinal crack small transverse cracks are also observed. Figure 12 (b) shows the magnified view of the single longitudinal crack obtained in the failed base metal tube.

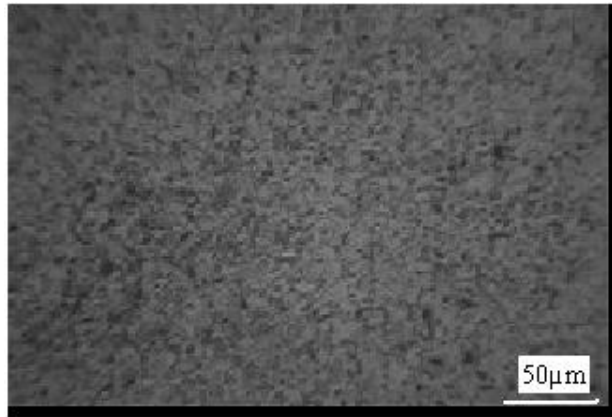
The microstructures of defect free surfaces of the failed base tube are shown in figure 13. The figure shows that the grain size is larger. The dark coloured

grains seen in the microstructure are the tempered martensite. The tempered martensite gives high creep strength at elevated temperatures. The large grain size also helps in preventing cracks. The carbides and carbonitrides formed are found on the grain boundaries.

**Fig.13 Microstructure of base in defect free region**  
Higher hardness is due to the result of the tempered martensite and the carbides

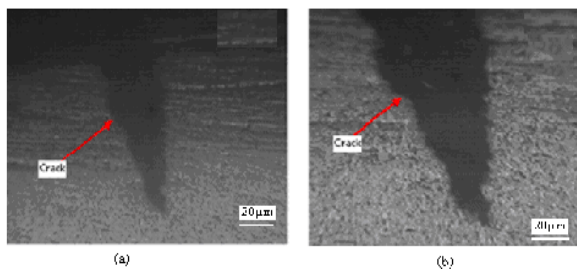
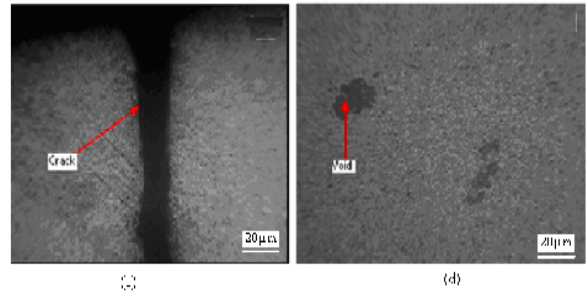
Through the optical microscope, the defect surfaces in the T91 base metal tube were identified and presented in figure 14 (a -d). From the figure 14 (a-c) it is clearly identified that large number of cracks was found in the failed base tube and figure 14(d) shows that voids like defects are also found. The cracks are developed from the heating surface (outer surface) of the tube and propagated towards the inner surface. Cracks and voids observed in the failed base tube are similar to the cracks observed in the failed tubes [8].

**Fig.14 (a-d) Cracks and voids identified in the failed base tube**

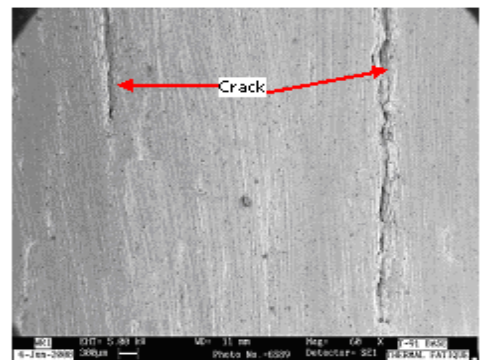
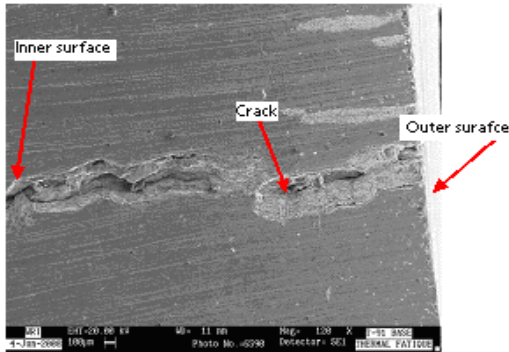
The cracks and voids observed in the optical microscope are subjected to SEM study to analyse the failures in detail. SEM analyses are carried out in defective surfaces of the base tube. The cracks observed in the SEM examination of the failed base tube are shown in figure 15(a-b). The cracks develop from the outer surface of the tube and propagate towards the inner surface. Similarly, it occurs in the circumference of the heated region of the tube. Micro-void formation is observed inside the cracked surface at higher magnification and it is clearly shown in figure 16 (a-b). When the cracked surface is further magnified, grain boundary cracks are also observed as shown in Figure 17. From figure 15 (a-b), it is clearly identified that the initial position of the crack width is high, while observing towards the inner surface, the growth rate of the crack increases due to the difference in temperature and rate of cooling. Due to these reasons cracks and voids are developed.

(b)  
**Fig.15 (a & b) Crack propagation in the failed base tube**

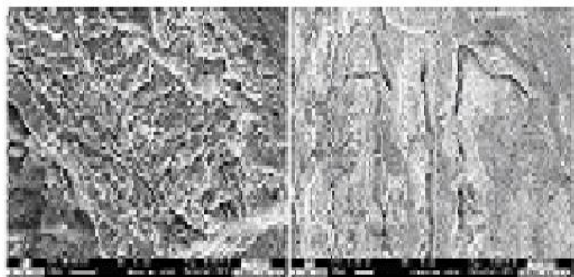
(a) (b)  
**Fig.16 (a&b) Grain boundary micro-void formation inside the crack**

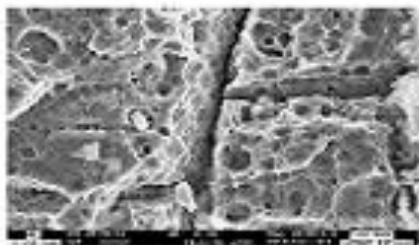
**Fig.17 Cracking along the grain boundaries**

On evaluating the micro study and SEM results, it is clearly observed that the cracks are developed from the heating surface (outer surface) of the tube and propagates towards the inner surfaces, which eventually cause failure of the tube. The cracks occurred in the tube is due to long time exposure in service temperature. Grain boundary cracks and micro – void formation is also observed inside the crack at higher magnification. The voids and cracks obtained in the tube specimen is the typical thermal fatigue crack, which is similar to the failures reported in tubes, subjected to thermal fatigue [8].

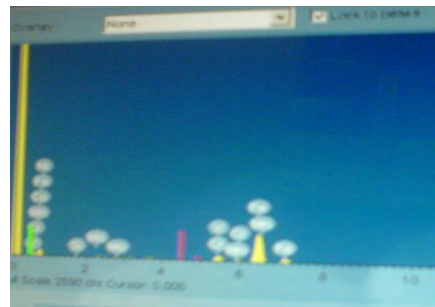
(a) Before thermal fatigue

From the spectrums and elemental results, it is found that both the base and failed specimens have the same spectrum which indicates the failure in not due to the segregation of any foreign elements during thermal cycling. The failure is due to the grain boundary crack as identified in SEM results, which is a typical thermal fatigue failure.

**Fig.18 (a & b) EDAX analyses of base and failed samples**
