SLIDING WEAR BEHAVIOUR OF AISI 304 AUSTENITIC STAINLESS STEEL AT ELEVATED TEMPERATURE

ABSTRACT

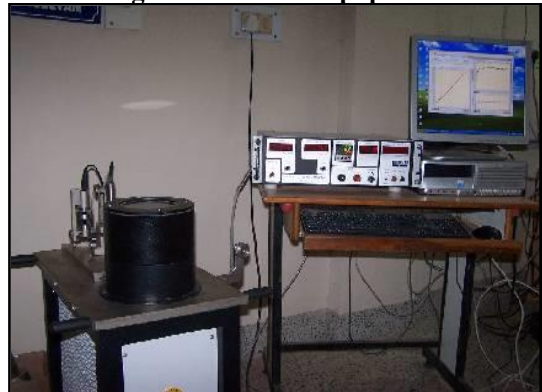
Fig. 1 Pin on Disc Equipment

The LVDT probe was positioned on the weights to measure displacement and the load cell to sense the tangential force. The disc was washed with acetone to protect the surface normally in dry sliding condition. Fig. 1 shows the pin on disc wear testing machine. The microstructure of AISI 304 SS using the etchant nital was taken in 400 x magnification. The parameter selected for the present study is shown in Table 1. The normal loads used were 30 and 50 N. The tangential velocities were 1m/s and 2m/s and with a wear track radius of 40 mm and 70 mm respectively. The experiments were performed at 30° C and 100° C

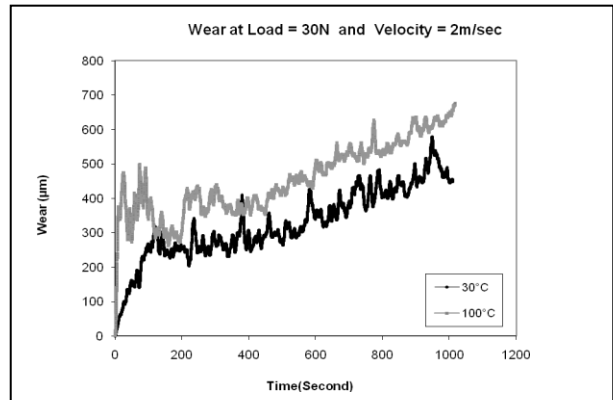
Fig. 5 Variation of Wear with Respect to Time

The wear versus time graph generated by Winducom 2006 software during the wear test both at room temperature and 100°C is shown in Fig. 5. Sliding wear mechanisms were dominated by plastic deformation. The graph corresponds to parameters 30N load and 2 m/s tangential velocity. From the graph we inferred that, initially the wear at 100° C was slightly higher than that of the wear at 30°C. After that, the variation progressively increases with time. From the

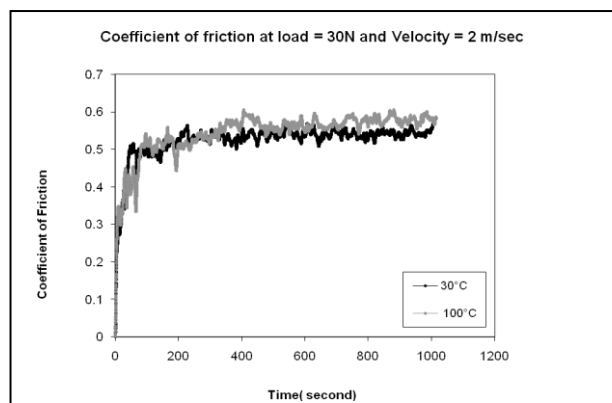
Fig. 6 Variation of Coefficient of Friction with Respect to Time

frictional load, the coefficient of friction was calculated with respect to time and it was plotted in graph corresponds to parameters 30N load and 2m/s velocity which is shown in Fig. 6. It was inferred that the coefficient of friction varies between 0.5 to 0.6 in both the temperatures of 30°C and 100° C conforming the dry sliding wear action. The Coefficient of friction was progressively increases with time.

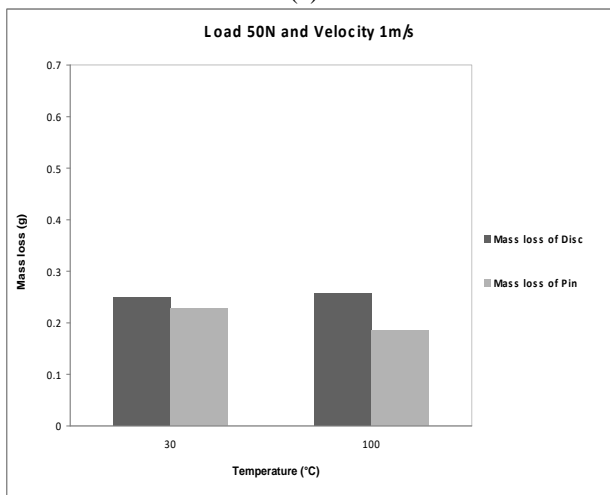
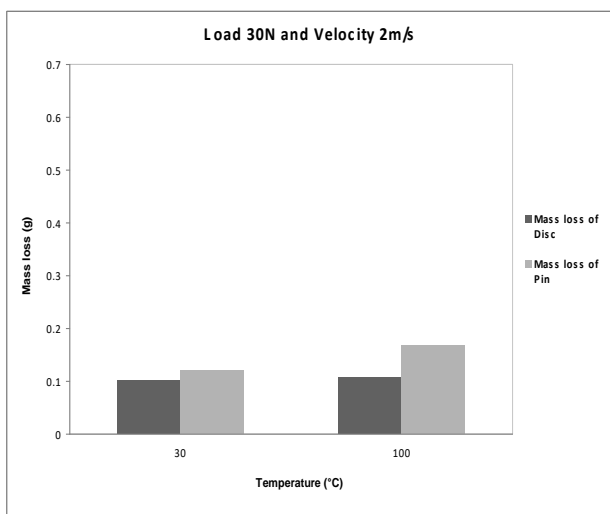
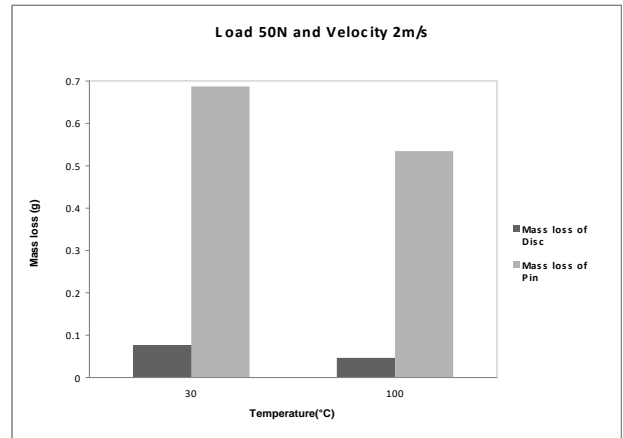
Fig. 7 (a-d) Mass Loss of Disc and Pin as a Function of Temperature, Load and Velocity

Fig. 7(a-d) shows the wear in terms of mass loss of both the pin and the disc as a function of temperature, load and velocity. It was explicit that in the velocity of 1m/s, mass loss of disc was grater than the pin mass loss. In the case of 2m/s velocity, the mass loss of pin was higher than the mass loss of the disc. The mass loss of pin increases as the load increases in higher velocity. The load and the velocity have linear relationship with the mass loss of the pin.

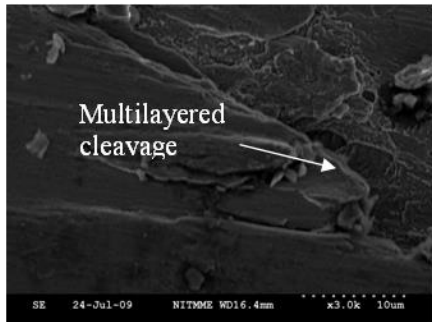
Fig. 8 SEM Micrograph of the AISI 304 Worn Surface under Load 30 N at 30°C (a) Velocity 1m/s (b) Velocity 2m/s

Fig. 8(a) shows the worn surface of Specimen 1. Debris and ridge was present in worn surface. Fig. 8(b) shows the worn surface of Specimen 2. A multi layered cleavage was seen in the worn surface along with small amount of debris. The worn surface was shown with evidence of a multilayered structure in the cleavage region. Fig. 9 (a) shows worn surface of Specimen 3. The sliding direction was well exposed by parallel shallow grooves. Fig. 9 (b) shows worn surface of Specimen 4.
