## TROUBLESHOOTING OF RAW MATERIAL HANDLING IN BAGASSE PULPING

\*Sakthi Vadivel K, Sivaraj C and Vigneshwaran K

Department of Mechanical Engineering, Builders Engineering College, Nathakadaiyur, Tamil Nadu- 638108, India

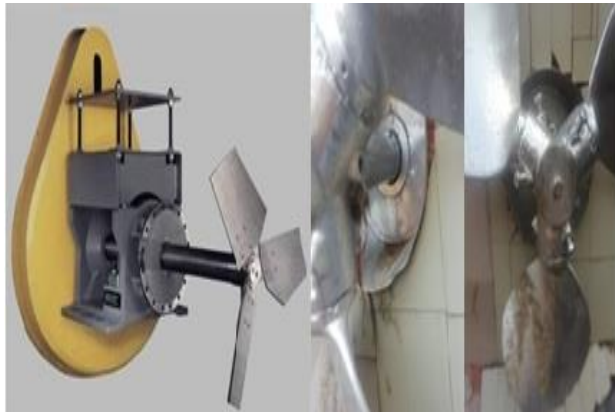
**Fig. 2 Agitator and stuffing box**

A stuffing box is an assembly that is used to house a gland seal. It is used to prevent fluid leakage, such as water or steam, between sliding and turning parts of machine elements. The stuffing box is shown in Fig.2. A stuffing box of a sailboat will have a stern tube that's slightly bigger than the prop shaft. It will also

have packing nut threads or a gland nut. The packing is inside the gland nut and creates the seal. The shaft is wrapped by the packing and put in the gland nut. Through tightening it onto the stern tube, the packing is compressed, creating a seal against the shaft. Creating a proper plunger alignment is critical for correct flow and long wear life. Stuffing box components are of stainless steel, brass or other application-specific materials.

A gland is a general stuffing box used to seal a rotating or reciprocating shaft against a fluid. The most common example is in the head of a tap (faucet), where the gland is usually packed with a string that has been soaked in tallow or similar grease. The gland nut allows the packing material to be compressed to form a watertight seal and prevent water from leaking up the shaft when the tap is turned on. The gland at the rotating shaft of a centrifugal pump may be packed in a similar way, and graphite grease is used to accommodate continuous operation. The linear seal around the piston rod of a double-acting steam piston is also known as a gland, particularly in marine applications. Likewise, the shaft of a hand pump or wind pump is sealed with a gland where the shaft exits the borehole. Other types of sealed connections without moving parts are also called glands; for example, a cable gland or fitting that connects a flexible electrical conduit to an enclosure, machine or bulkhead facilitates assembly and prevents liquid or gas ingress. The stuffing box will be placed between the gear box and the agitator blade. Using a stuffing box, the damage should be avoided, and the lifetime of the agitator and bearing will increase. The efficiency also increases.

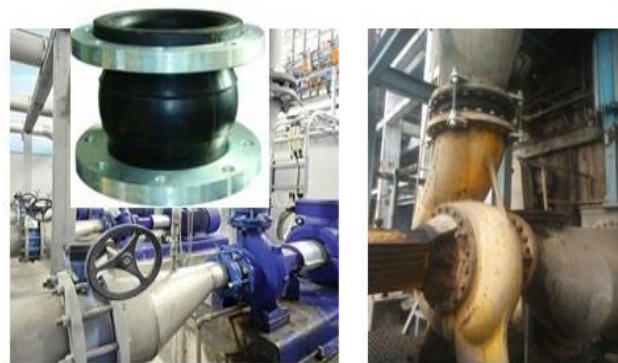
**Fig. 3 Centrifugal pump and Inspection Dummy set-up**

The pump continuously pumps the wed bagasse from the reclaim chest to the destoner. During that process, bagasse along with foreign material may jam the pump impeller. To remove the foreign materials in the impeller, the whole pump set-up needs to be dismantled. It takes more time. To reduce work time in the pump inspection dummy is used. If any foreign materials jam in the pump impeller, there is no need to disassemble the whole pump; stop the pump-open the inspection dummy and remove the foreign materials in the pump impeller. It is shown in Fig.3

As with any other unrestrained expansion joint, rubber bellows will extend under pressure. Their pressure thrust varies with length as the shape of the bellows changes. However, the forces involved are just as large, and the pressure thrust should be calculated by multiplying the cross-sectional area by the maximum pressure. Tie rods should be fitted to prevent the bellows from extending, or the pipework should be anchored well. It is shown in Fig.3.
