## COMPARISON OF PREDICTED AND EXPERIMENTAL THERMAL FATIGUE LIVES OF T -91 STEEL TUBE

G.R.Jinu<sup>1</sup>, \*P.Sathiya<sup>1</sup>, A.Rathinam<sup>2</sup> & G.Ravichandran<sup>2</sup>

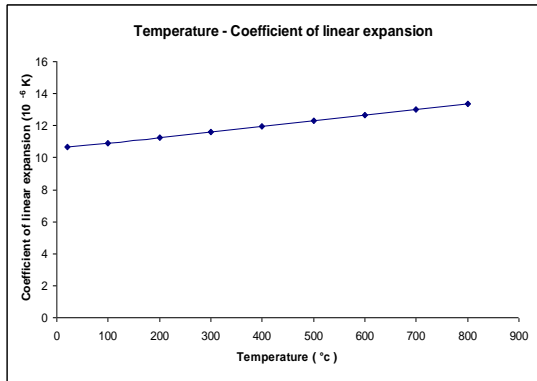
**Fig.4 Variation of coefficient of linear expansion with temperature [13]**

From figure 4, the linear thermal expansion corresponding to 800°C is  $13.38 \times 10^{-6}$  K and the difference in temperature is 800°C ( $\Delta T$ ).

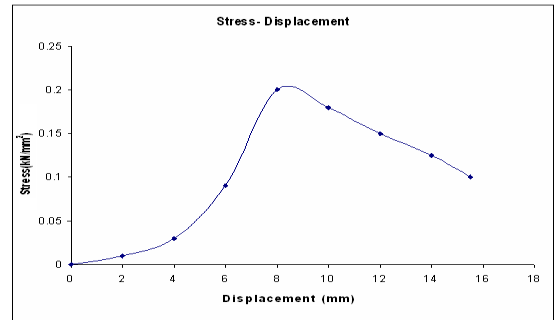
**Fig.8 Stress- displacement graph corresponding to 800°C**

Using the above equation-2, the linear strain is found to be  $1.07 \times 10^{-2}$ . From the stress- displacement graph (Figure 8) at 800°C the fracture stress ( $\sigma_f'$ ) and fracture strain ( $\varepsilon_f'$ ) are found to be 100 N/mm<sup>2</sup> and 0.2011 respectively. From Figure 6, the modulus of elasticity ( $E$ ) for 800°C is  $1.55 \times 10^5$  MPa. The fatigue strength exponent and fatigue ductility exponent are -0.12 and -0.7. All the above values are substituted in equation (1) and it is identified after 97 cycles, failure will occur.
